GENWAL RESOURCES, INC
CRANDALL CANYON MINES
C/015/032

CHANGE TO THE
MINING AND RECLAMATION PLAN
TO INCLUDE

MINE DISCHARGE WATER
IRON TREATMENT FACILITY

AND ABATEMENT ACTION FOR
CITATION 10043

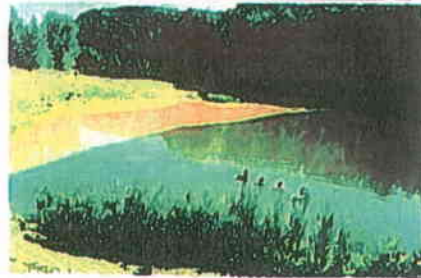
Photos are of an installation that's treats 720,000 gallons per day of net alkaline Acid Mine Drainage that contains 105 mg/l of Iron. Effluent meets NPDES and Pa. DEP discharge limitations. No chemicals are used in the treatment. Land area is twenty times smaller than recommended for passive systems.

The Maelstrom Oxidizer is an apparatus and method for mass transfer of oxygen into a liquid to strip carbon dioxide and to oxidize and precipitate metals.
